TECHNICAL REPORT ARCCB-TR-01005

**LASER PULSE HEATING SIMULATION OF FIRING  
DAMAGE ON COATED GUN BORE SURFACES**

**P. J. COTE  
G. KENDALL  
M. TODARO**

MARCH 2001

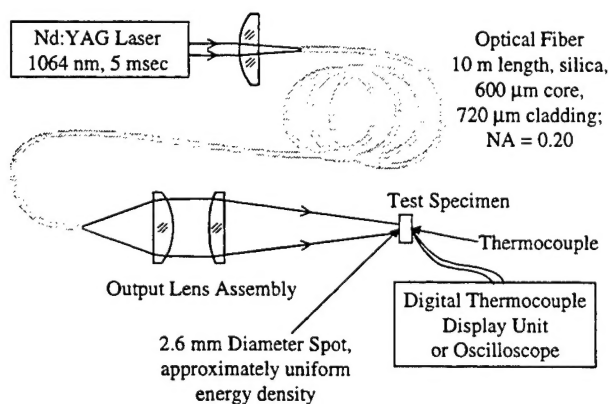
Radiation of wavelength 1064 nanometers from a neodymium-doped yttrium aluminum garnet (Nd:YAG) laser is delivered to the test specimen surface as shown in Figure 1. Lenses focus the light from the laser rod into a 10-meter, coiled length of all-silica optical fiber with core diameter of 600 micrometers, cladding diameter of 720 micrometers, and numerical aperture of 0.20. An optical fiber is used both for convenience and for assurance of a uniform energy distribution at the sample surface. A lens assembly is used at the output of the fiber to form a magnified image of the end face of the optical fiber onto the specimen surface. Thus, the spatial distribution of energy at the specimen surface is approximately uniform over a circular spot with a diameter that depends upon the diameter of the optical fiber core and the magnification of the output optics.

Figure 1. Schematic of pulsed laser heating apparatus.

The pulse duration is 5 milliseconds (Full-Width Half-Maximum (FWHM)), and the spot diameter at the specimen surface is typically 2.6 millimeters. Given typical coating thicknesses of 0.1-mm, the spot diameter to coating thickness ratio is 26, so that a large portion of the central spot area can be assumed to replicate the essentially one-dimensional heat flow through the coating at the bore surface.

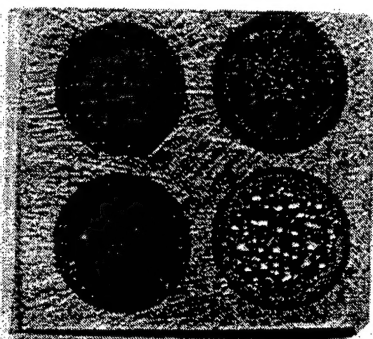
Figure 2 shows a 6-mm x 6-mm uncoated steel specimen that was subjected to a series of pulses. The top left area was exposed to one pulse, the bottom left two pulses, the top right five pulses, and the bottom right area twenty pulses.

Figure 2. Uncoated steel specimen exposed to laser pulse heating showing effects of 1, 2, 5, and 20 pulses.

The figure illustrates one of the conveniences of the method, in that numerous experiments can be performed on a single, small specimen.

As shown in Figure 2, an uncoated specimen of gun steel was subjected to a series of pulse treatments with absorbed energy maintained at approximately  $1 \text{ J/mm}^2$ . A heat-affected zone forms after a single pulse. The depth of the heat-affected zone does not appear to be a function of the number of pulses, but the microstructure can be observed to progress smoothly from the initial tempered martensite to the hard, etch resistant, untempered martensite layer. Thus, the depth of the heat-affected zone may serve as an approximate measure of the temperature at that point using the equilibrium phase diagram. This is possible because after a few pulses, the carbon can be assumed to have gone into solution and the rapid heating, estimated as high as  $\sim 10^6 \text{ }^\circ\text{C/s}$ , is actually an "upquench," bypassing the diffusion-controlled, tempering process. The high-strength, untempered martensite can thus be assumed to transform directly to austenite. It follows that this unusual process also occurs on gun bore surfaces whenever a heat-affected zone has formed.

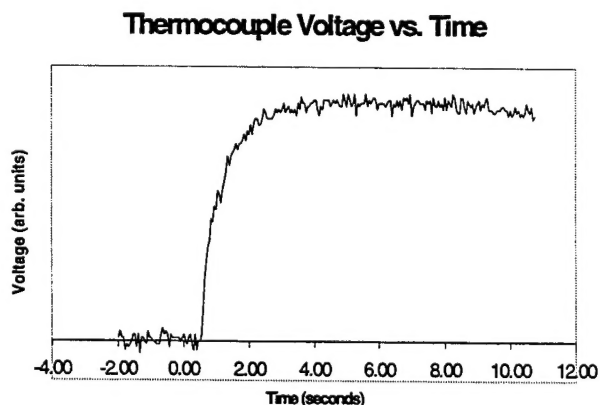
A thermocouple is adhered to the back surface and the specimen is thermally insulated. Figure 3 shows a typical plot of the thermocouple voltage after laser pulse heating for a thermocouple adhered to the back surface of the specimen. This method was used to maintain the absorbed energy per pulse at approximately  $1 \text{ J/mm}^2$ , which is expected to be representative of conventional high-temperature propellants.

Figure 3: Typical plot of thermocouple voltage versus time after laser pulse heating for a thermocouple adhered to the rear surface of the specimen.

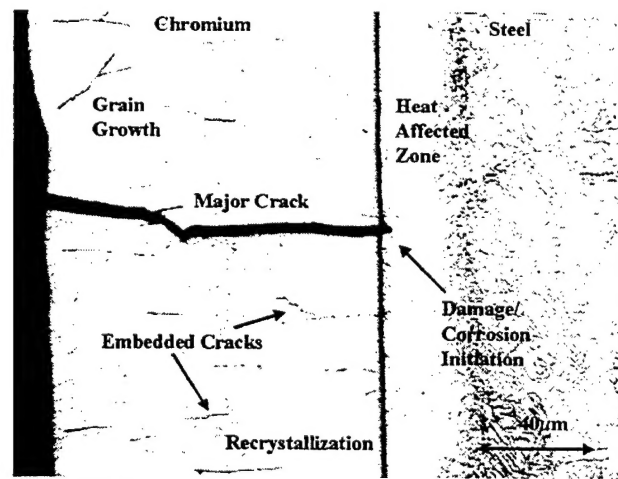
Figure 4 is an optical micrograph of a cross section of an HC chromium electrodeposit on a steel substrate.

Figure 4. Laser pulse heated specimen showing metallurgical changes, chromium cracking, and damage initiation in steel after 20 pulses.

This specimen area was subjected to 20 pulses at incident energy 2-3 J/mm<sup>2</sup>. The figure exhibits all the features of a fired chromium plated gun bore section as shown in Figure 5. This includes recrystallization and grain growth of the chromium, wide cracks in the chromium, a heat-affected zone in the steel, and corrosion attack (iron oxide) at the tip of the cracks in the chromium. The fine surface and embedded cracks are present in the as-prepared condition.

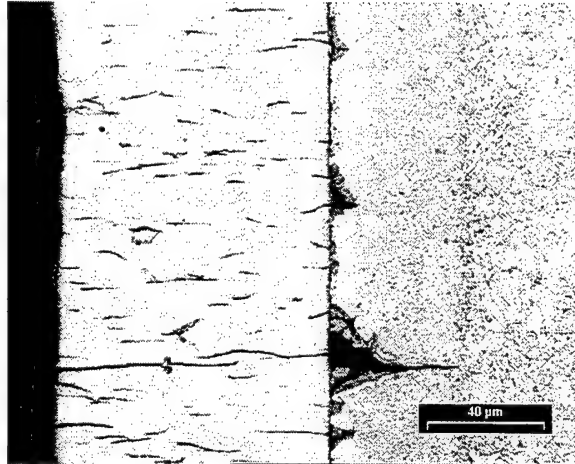
Figure 5 is from a 120-mm gun tube that had fired approximately 80 experimental rounds and 225 conventional rounds (See References 4 and 5). The figure shows sites of damage initiation with associated gray layers and white layers. Also shown is an area where damage in the steel has progressed beyond damage initiation to crack initiation. The major cracks (cracks that extend through the coating) in Figure 4 are the result of thermal pulsing alone. This illustrates that mechanical loading during firing is not a major factor in the enlargement of chromium cracks. Experiments were also conducted to compare the development of cracks on HC and LC chromium specimens after 1, 5, and 20 laser pulses.

Figure 5.. Damage initiation and propagation in steel in a 120-mm gun bore.

The reaction layers here are relatively thin so that chemical attack (rapid oxidation) plays only a limited role in the development of the damaged area. One difference between these results and the damage initiation sites in fired guns, as shown in Figure 5, is that the pitted areas in fired guns are often more solidly filled with oxide and/or sulfide (refs 4,5). This can be attributed to differences in number of rounds and oxygen partial pressures during firing.

For completeness, it should be pointed out that in these investigations, only damage initiation sites in fired gun tubes (e.g., Figure 5) were examined because of the focus on initiation processes. The specimens often exhibit cracks that have progressed deep into the steel, well beyond the compressively stressed, heat-affected zone. In fired gun tubes, with much higher numbers of rounds than in the present laser pulse experiments, it is likely that mechanical fatigue and thermal fatigue play a role in development of deep cracks. The possibility also exists that environmental effects, such as hydrogen embrittlement (ref 7) are present in such cases.

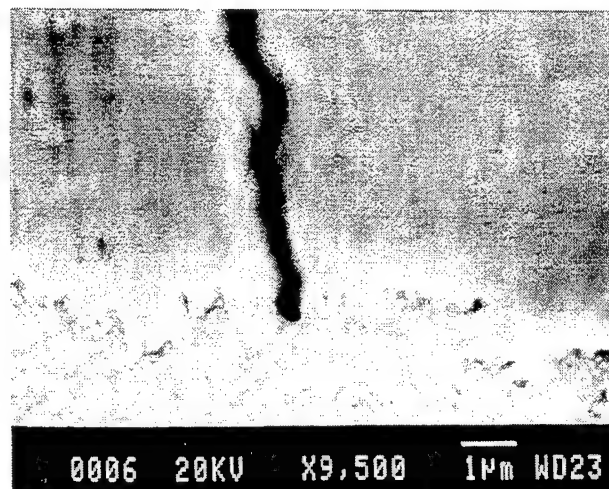
Figures 6 through 9 are a series of SEM micrographs of various damage initiation sites at the chromium/steel interface for the specimen shown in Figure 1. Figure 6 is a typical result for 5 pulses. Figures 7, 8, and 9 are typical results for 20 pulses.

Figure 6. Five pulses.

The major cracks extend all the way through the chromium coating to the substrate. As shown in these figures, the damage extends into the substrate to form blunt corroded extensions of the chromium fractures in the steel heat-affected zone (untempered martensite). Figures 8 and 9 are unetched and etched versions to show the reaction zones (gray layers) surrounding the crack extension into the steel. Wavelength dispersive analysis identified these reaction zones as iron oxide (wustite, FeO). Small fissures are present in the iron oxide and their orientations are generally perpendicular to the steel surface of the pit. These features are similar to those seen in the reaction zones of fired tubes (refs 4,5).

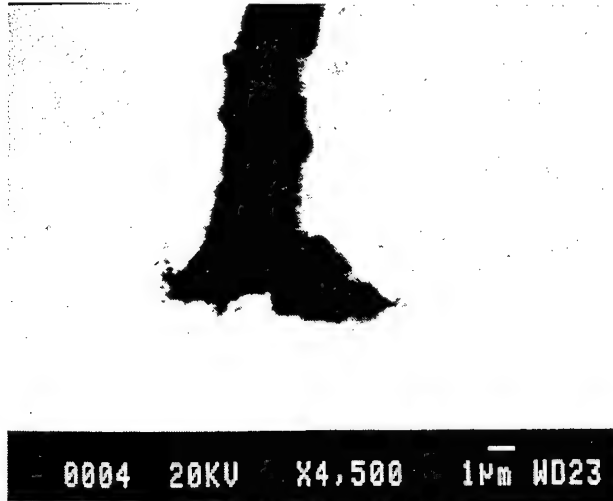
Figure 7. Twenty pulses.

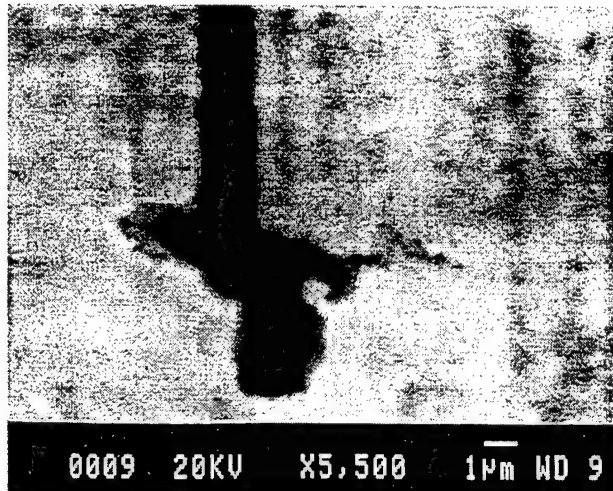
Figure 8. Twenty pulses (unetched version).

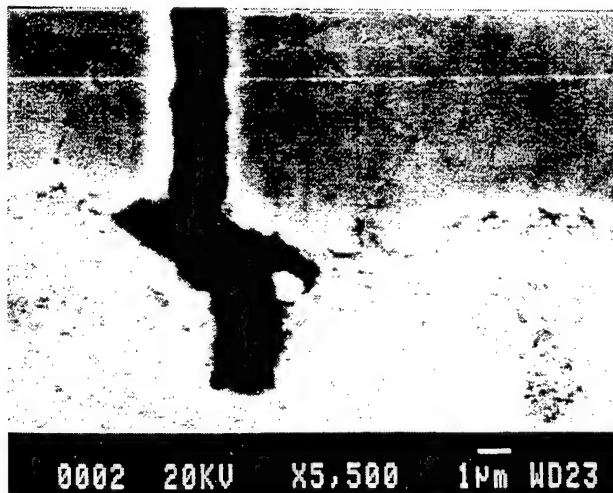
Figure 9. Twenty pulses (etched version).

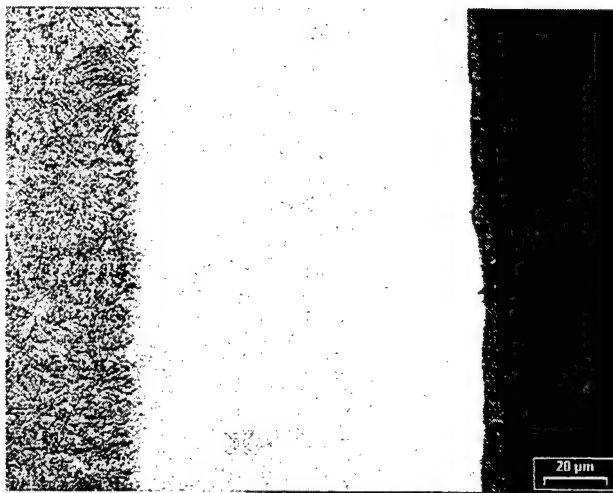
Figure 10 is a cross section through the 20-pulse zone of this specimen showing the heat-affected zone and a reaction layer at the surface. The remarkably thick reaction layer (gray layer) results from rapid oxidation at the unprotected surface. A thin layer is also observed after five pulses. It is necessarily the same as the reaction product that forms at the chromium crack tips (e.g., Figures 8 and 9) in plated specimens. An inspection of the surface shown in Figure 2 at higher magnification reveals that the oxide layer has melted during laser pulsing. This is consistent with the low eutectic temperature of FeO ( $1371^\circ\text{C}$ ). Melting of the insulating FeO may be promoted by the poor thermal conductivity of the layer.

Figure 10. Section of uncoated steel specimen after 20 laser pulses showing thick reaction layer and heat-affected zone.

Melting is not observed in this steel specimen. This result, along with the general observation of rapid oxidation (refs 4,5) in fired guns, illustrates that rapid oxidation, along with the melt-wipe process, is a viable mechanism in high-rate erosion in gun bores. (Steel melting at the surface can be induced with higher-incident laser energies. This would correspond to the extreme case for erosion rates.) The results on unplated steel further demonstrate that laser pulsing in air reproduces the principal gas/metal reaction (rapid oxidation) in the fired gun tubes.
